ANCIENT KHOTAN

DETAILED REPORT OF ARCHAEOLOGICAL
EXPLORATIONS IN CHINESE TURKESTAN

M. AUREL STEIN

VOL. II PLATES

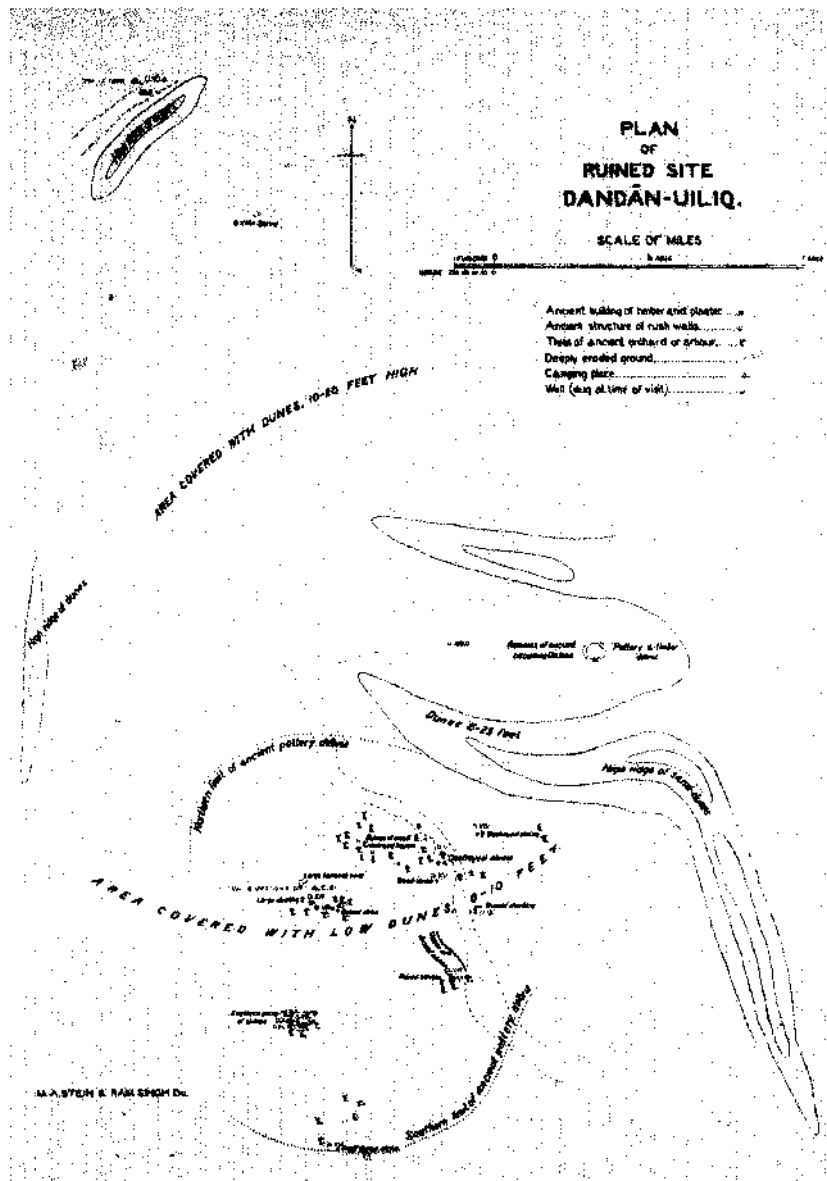
PLAN
OF
RUINED SITE
DANDĀN-UJLIQ.

- Ancient building of timber and plaster
- Ancient structure of rush walls
- Thick of ancient orchard or garden
- Deeply eroded ground
- Camping place
- Wm (as at time of visit)

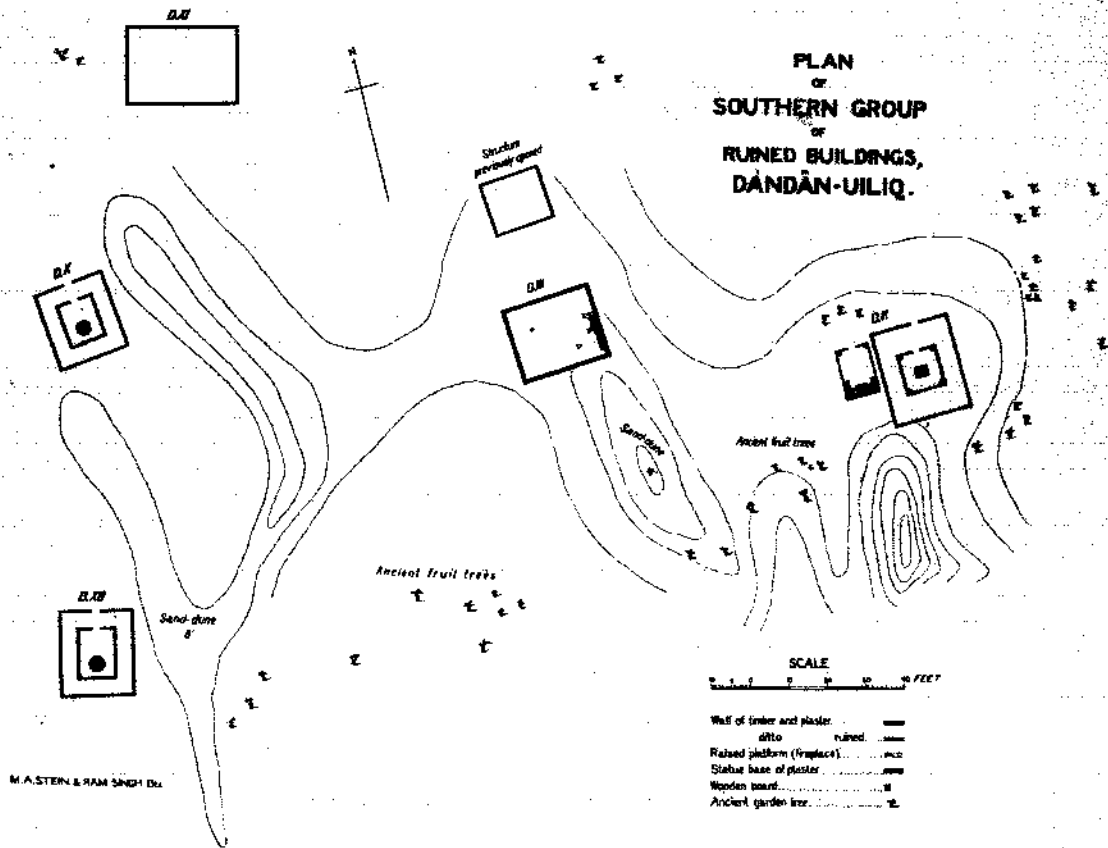
PLAN
OF
SOUTHERN GROUP
OF
RUIINED BUILDINGS,
DĀNDĀN-UULIQ.

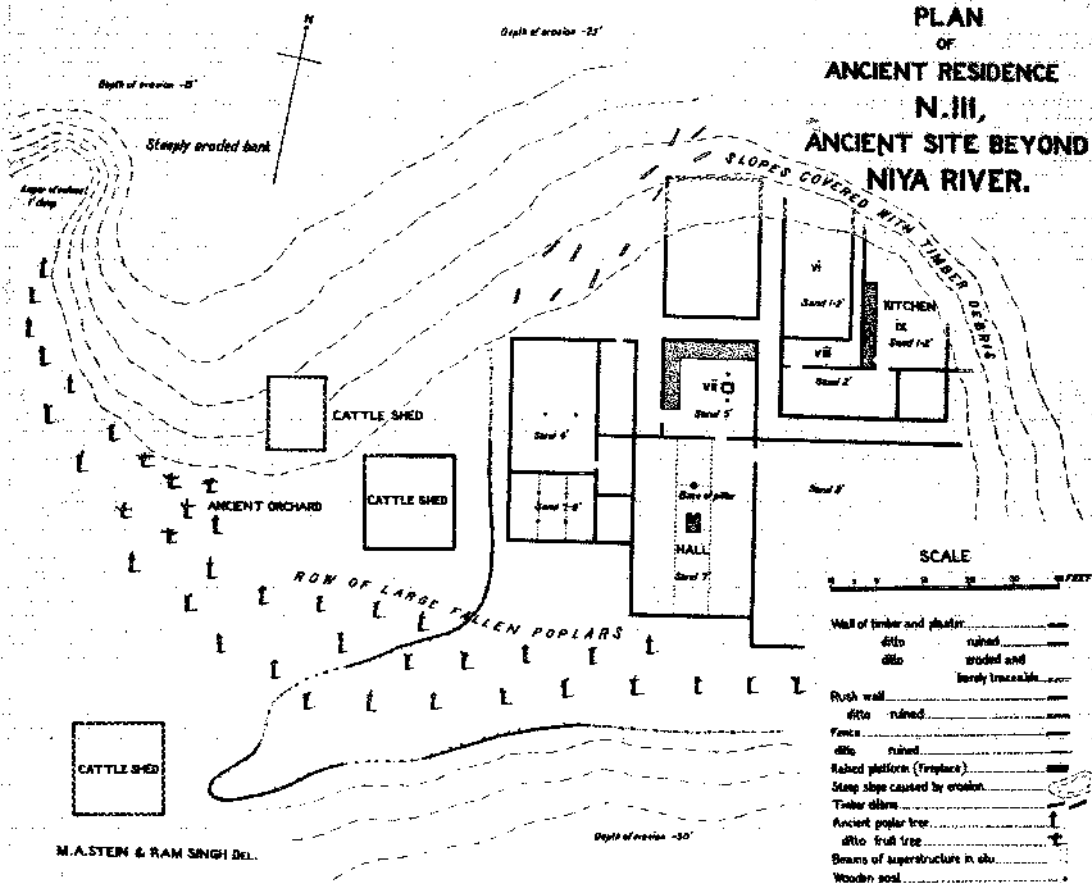
PLAN
OF
ANCIENT RESIDENCE
N. III,
ANCIENT SITE BEYOND
NIYA RIVER.

- Wall of timber and plaster:
 - ditto ruined
 - ditto eroded and
 - barely traceable
- Rush wall:
 - ditto ruined
- Fence:
 - ditto ruined
- Flashed platform (Fireplace):
 - eroded and
- Steep slope caused by erosion:
 - eroded and
- Timber pillars:
 - eroded and
- Ancient poplar tree:
 - eroded and
- ditto fruit tree:
 - eroded and
- Beams of superstructure in situ:
 - eroded and
- Wooden post:
 - eroded and

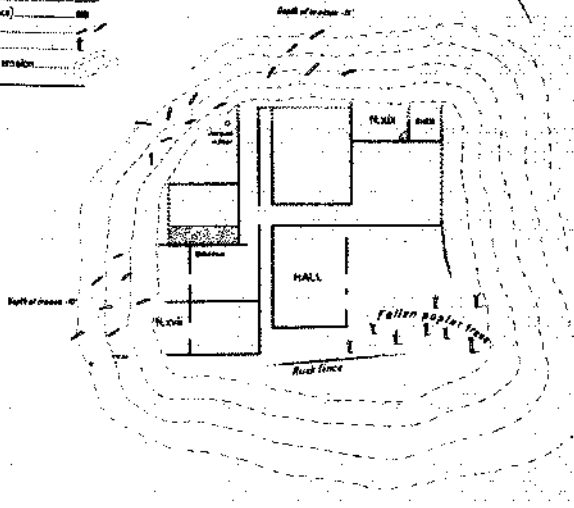
PLAN
OF
RUINED DWELLING
N.VII,
ANCIENT SITE BEYOND
NIYA RIVER.

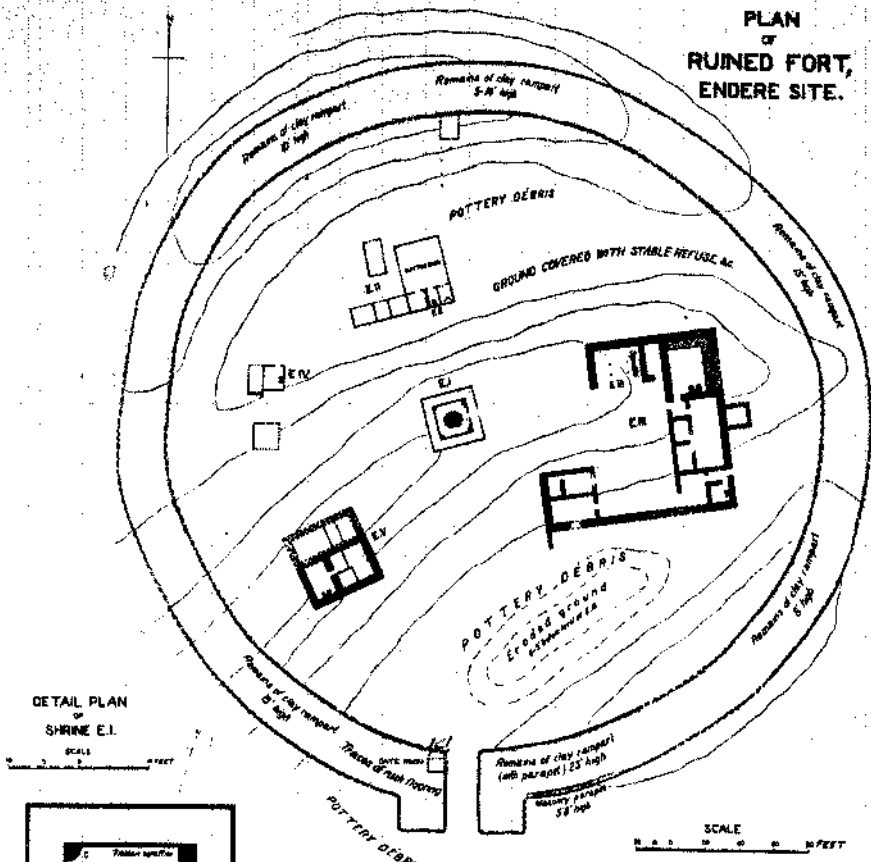
PLAN
OF
RUINED FORT,
ENDERE SITE.

DETAIL PLAN
OF
SHRINE E.1.

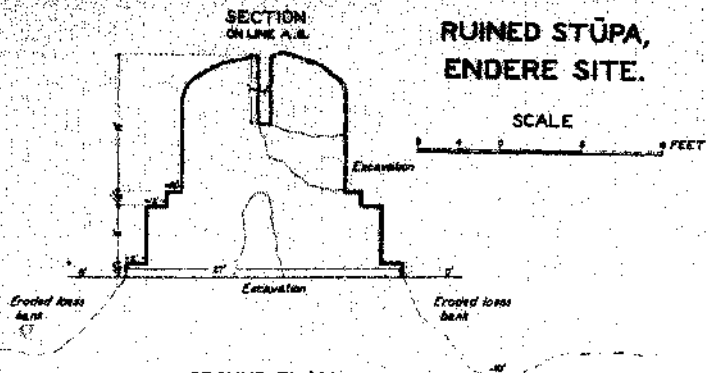
RUINED STŪPA, ENDERE SITE.

GROUND PLAN
